Holy Rosary Tacoma Due Diligence Assessment

Holy Rosary Campus

Building Assessment – Initial Issue

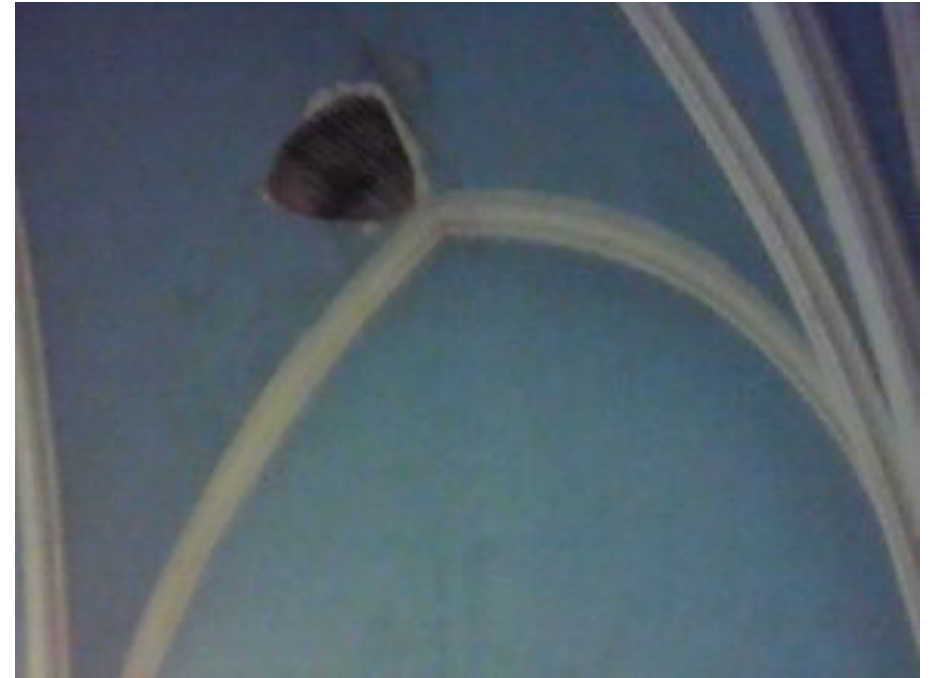
- Roof leak resulted in wet interior plaster. Section above choir loft falls to nave (approx. 35'). Adjoining areas of loose plaster and ceiling tiles. Area within nave closed off.

1) Repair roof area around bell tower and interior plaster damage

- Further moisture related plaster damage is noted in church.

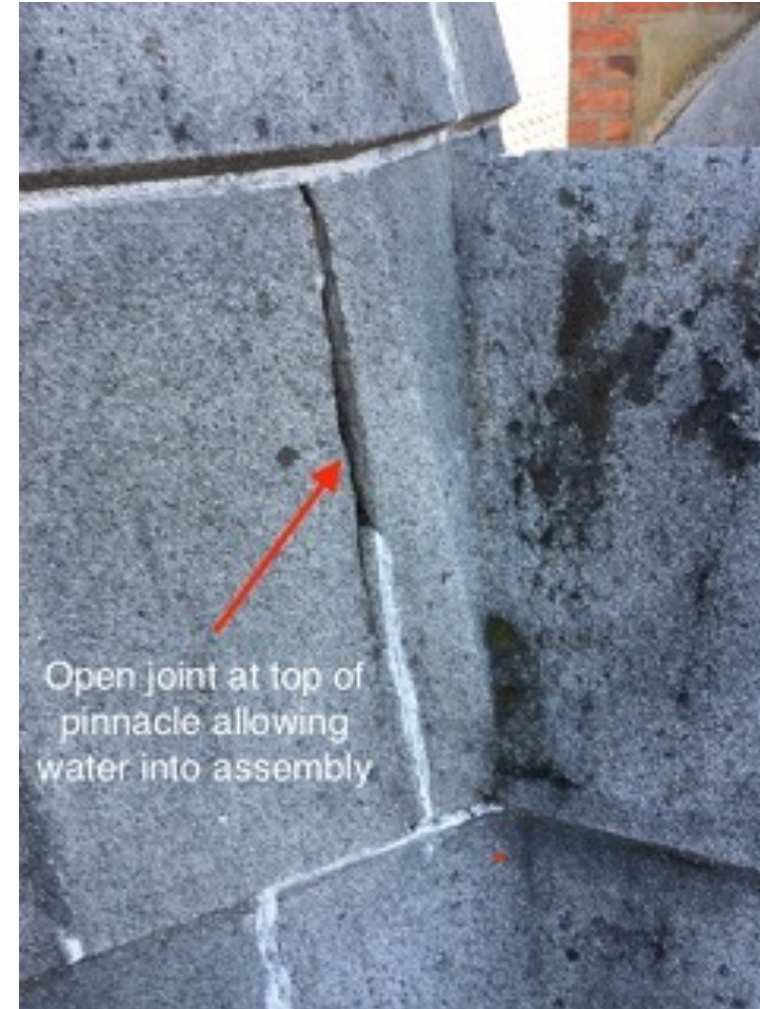
Building Assessment – Bell Tower

4) Bell Tower structure has been compromised due to water leakage and lacks seismic upgrades

- Consultants recommend repair to brick, concrete elements, and flashing to stop water intrusion.
- Repair to original tower reinforcing.
- Upgrade tower structural system to avoid either collapse or tower falling onto church during a seismic event.
